A. Bezuidenhout, M. Jogiati, N. Mbedle, D. Panday,  
N. Nkomo, K. Baloyi, S. Mhlanga, M. Phewa,  
M. Govender, N. Nxumalo, M. Fadal, D. Ramokotjo  
Transnet Freight Rail  
alvino.bezuidenhout@transnet.net

The temporary plate girder railway bridge

# Vryburg Bridge Project: The design and construction of a temporary plate girder railway bridge

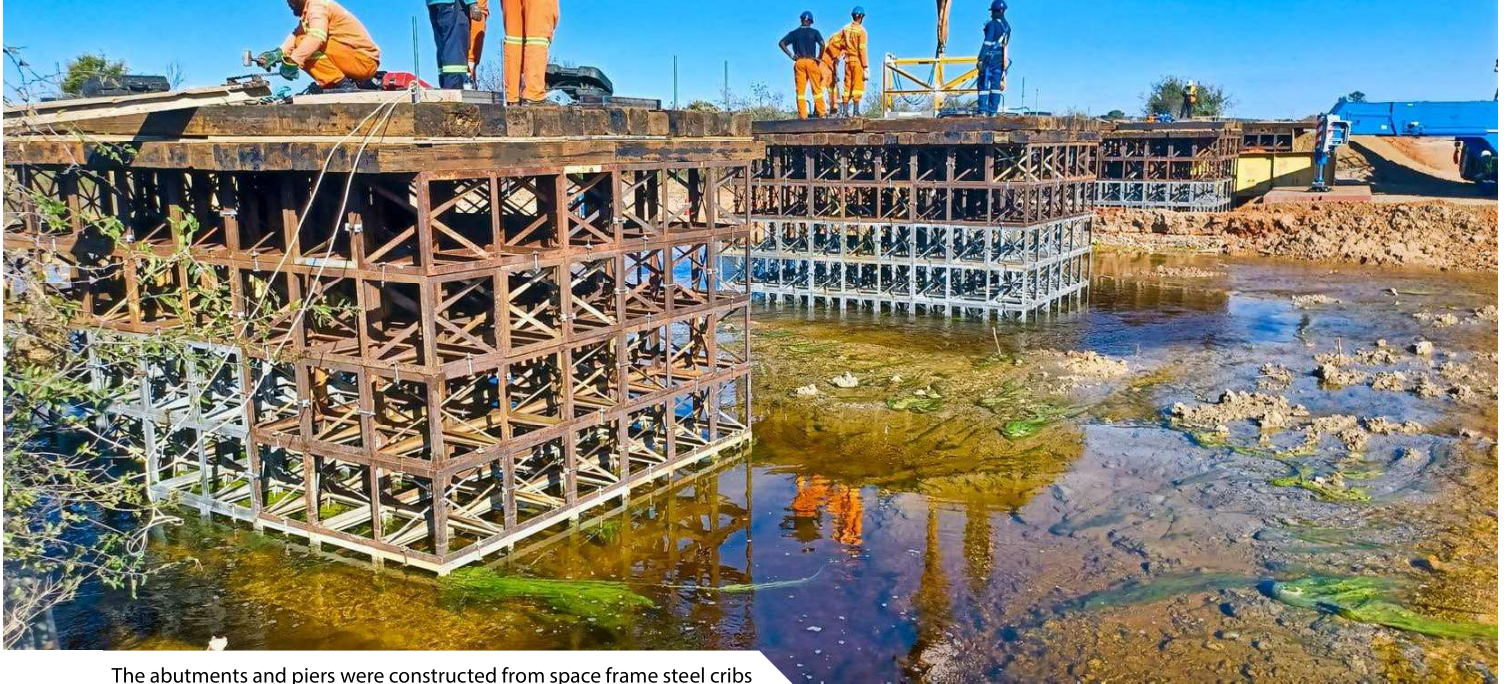
The abutments and piers were constructed from space frame steel cribs

The auxiliary and southern abutments and both piers were constructed from space frame steel cribs (0.61 m × 0.61 m × 1.83 m), fabricated using 51 mm equal leg angles and diagonal bracing bars, having a load carrying capacity of 200 kN.

Individual steel cribs were assembled in a staggered pattern and clamped using bolted clips to enhance stiffness and load transfer through the assembly. With all steel cribs designed at the same transverse width of 5.49 m, the longitudinal widths for the piers and auxiliary abutment were 3.66 m, while the southern abutment's design width was 1.83 m. After 48 hours of curing, each crib assembly was lowered and aligned into position (using guide ropes, slings and a large 30-ton hydraulic excavator) on each of the cured foundations before being secured with a chemical adhesive and U-shaped Y20 bars, anchored to a drilled depth of 300 mm, thus increasing the sliding resistance of the crib assembly under the effect of lateral and eccentric loads.

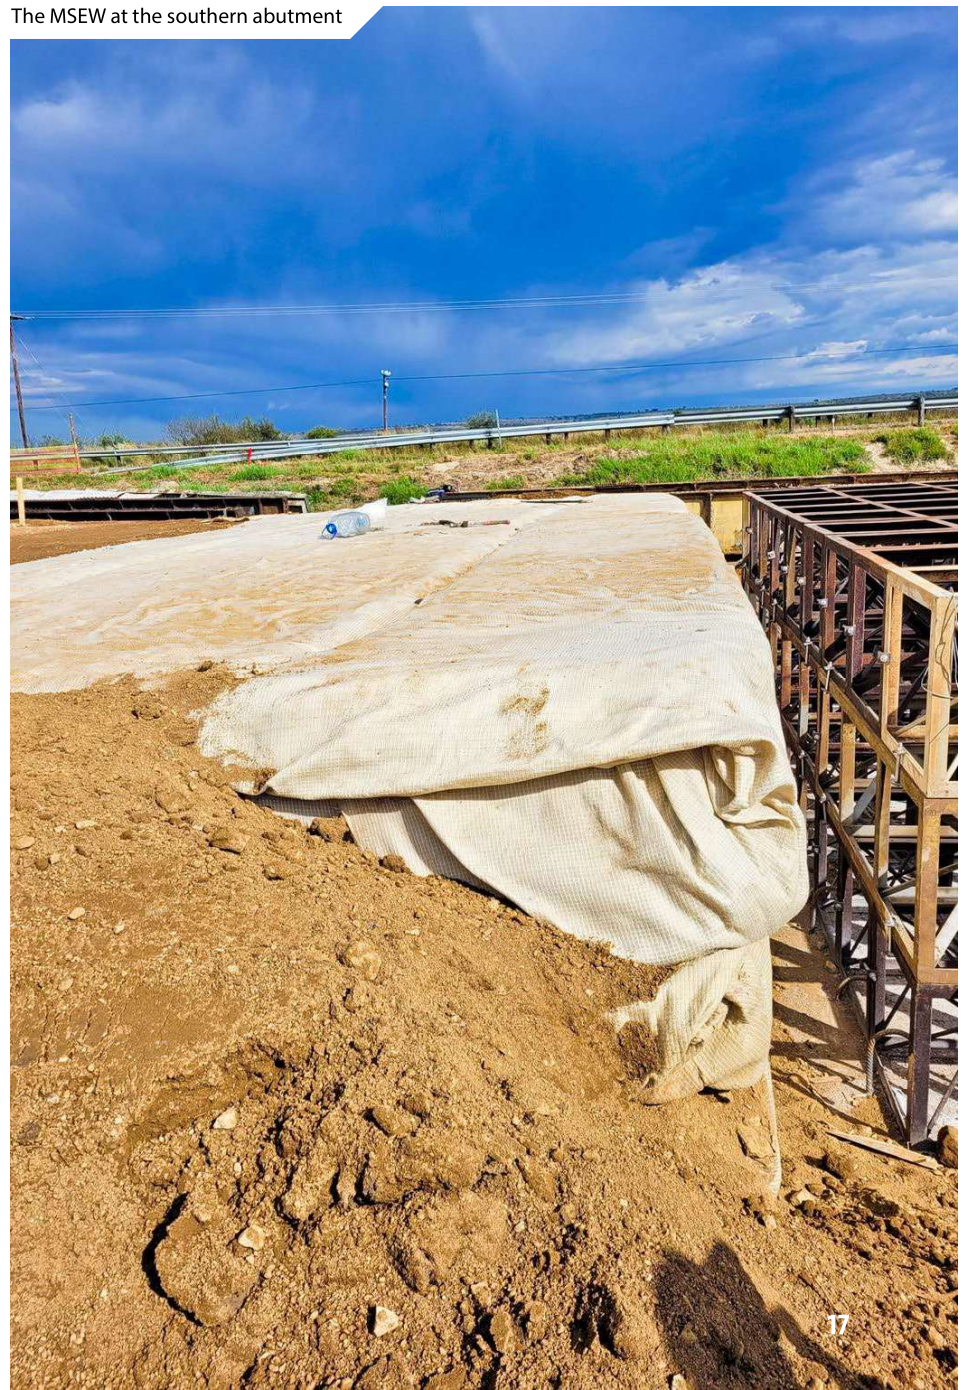
The MSEW at the southern abutment

A 3.2 m (high) × 2.6 m (wide) × 7.5 m (long) retaining wall was required between the southern (crib) abutment and existing (southern) railway embankment to facilitate track transition and retain the embankment fill.

A MSEW was the most cost effective and least labour intensive option compared to conventional lateral support systems. The MSEW was constructed using cement-stabilised G2 fill, compacted to 88% relative density, with the soil reinforced using rock grid PC 200/200 – forming a 90° wrap-faced soil-reinforced wall. After being stabilised using 5% to 6% cement to prevent bulging of the wall and to improve the soil's unconfined strength, the face of the MSEW was protected to avert UV degradation of the high tensile strength composite geotextile fibres.

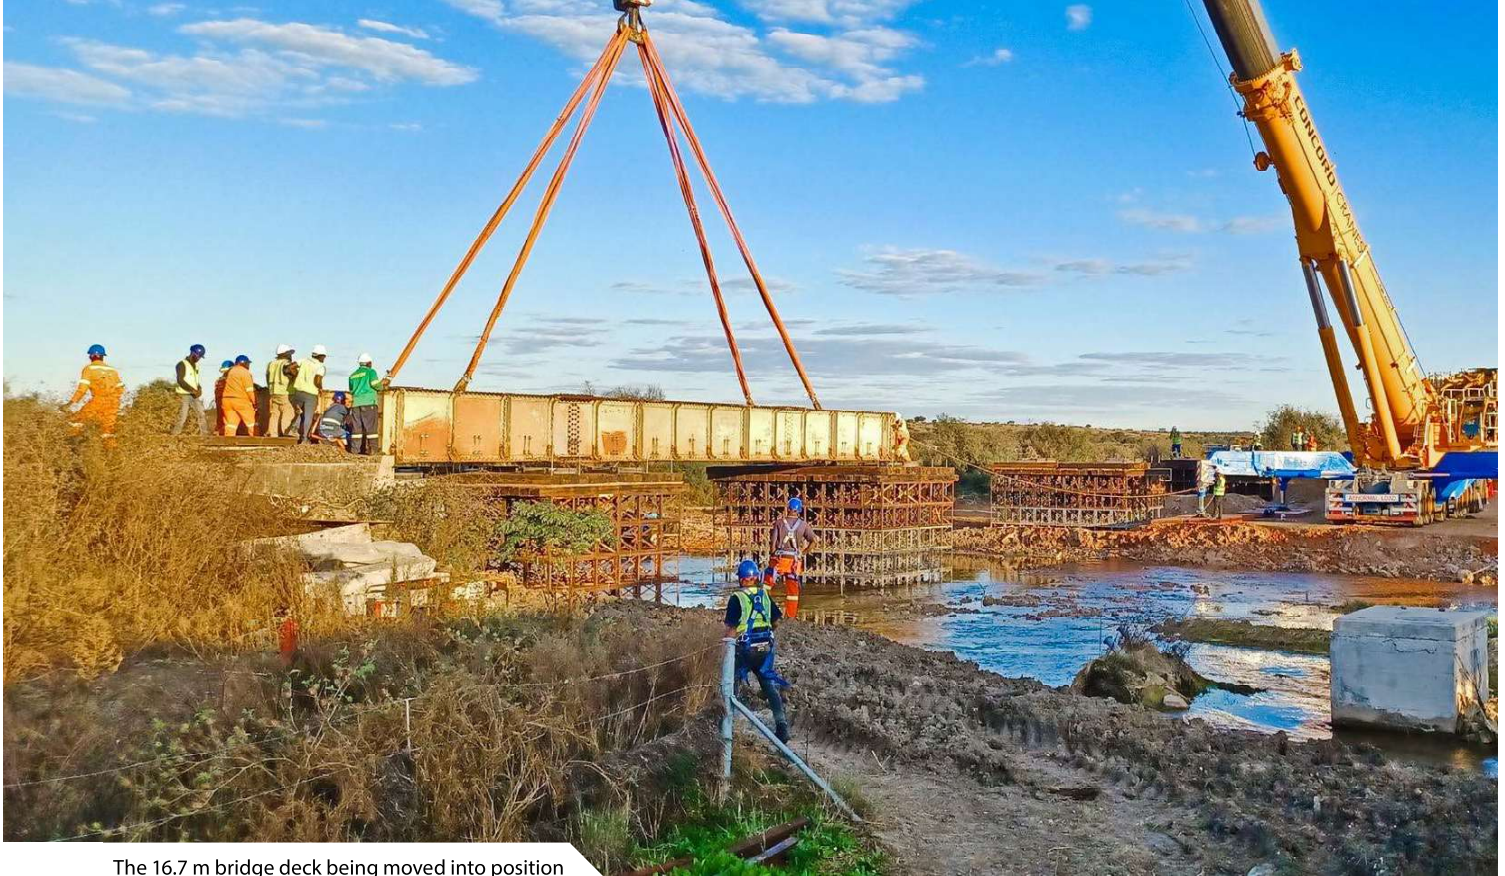
The 16.7 m bridge deck being moved into position

A rigging study conducted by Concord Cranes concluded that the installation of all three prefabricated spans required a 440 ton hydraulic crane with a minimum heavy boom length of approximately 40 m and a working radius of 28 m. This lifting operation utilised an 80 ton capacity crane hook and a four-legged sling configuration with an approximately 90° angle between diagonally opposed legs, with two slings assumed to carry the full load and the two remaining slings fulfilling the function of load balance.

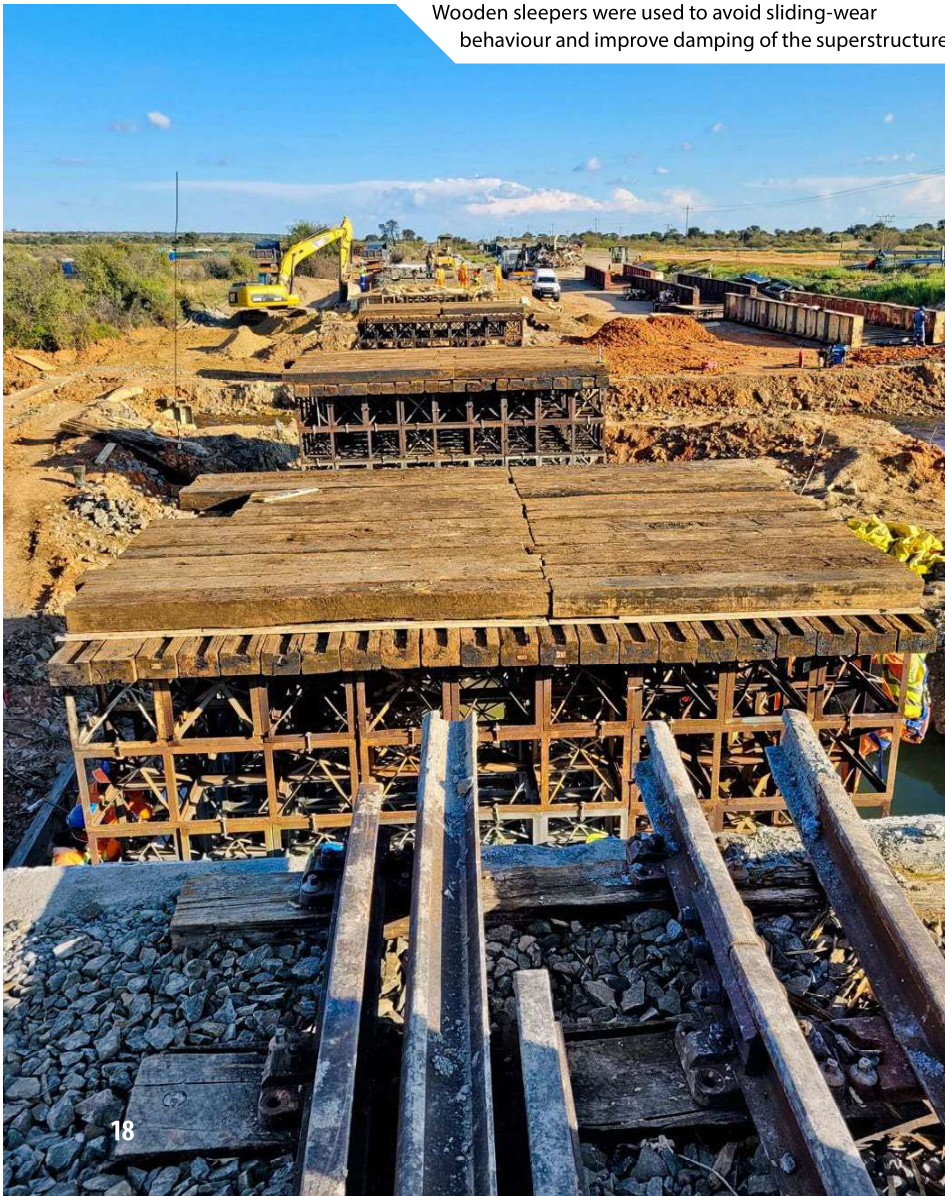
Wooden sleepers were used to avoid sliding-wear behaviour and improve damping of the superstructure

To avoid sliding-wear behaviour and improve the damping of the superstructure, wooden sleepers were introduced between the steel cribs and plate girders before the girders were secured to the crib piers and abutments.

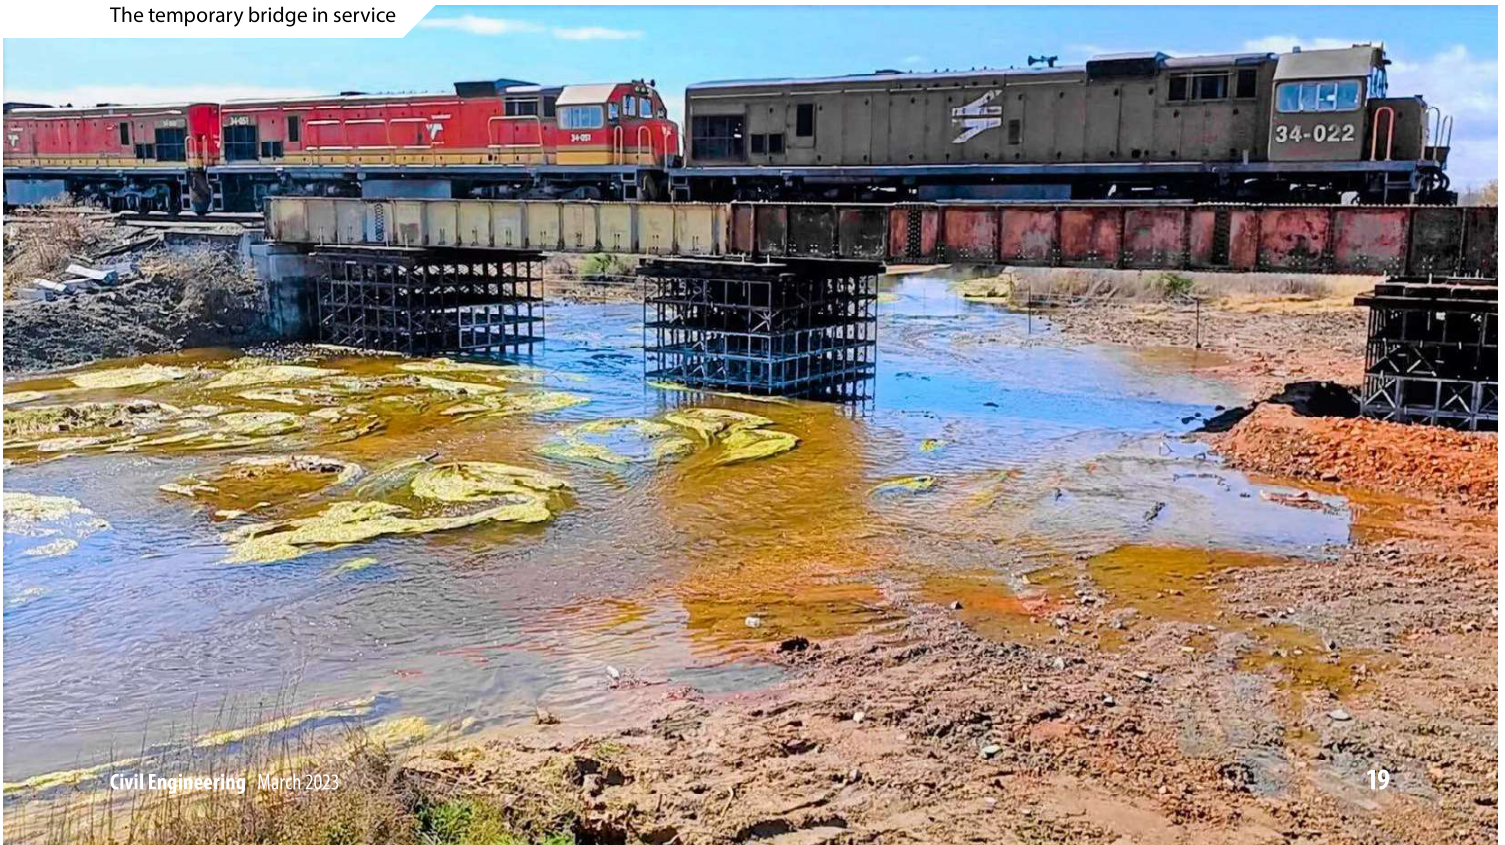
The temporary bridge in service

As a result of strict geometric standards required by Transnet's Manual for Track Maintenance (2012), the vertical and horizontal deck alignments were achieved with discrepancies of less than 5 mm, permitting the restitution of track geometry to an optimal standard. Routine deflection monitoring, aided by a digital level of the bridge deck, is ongoing.

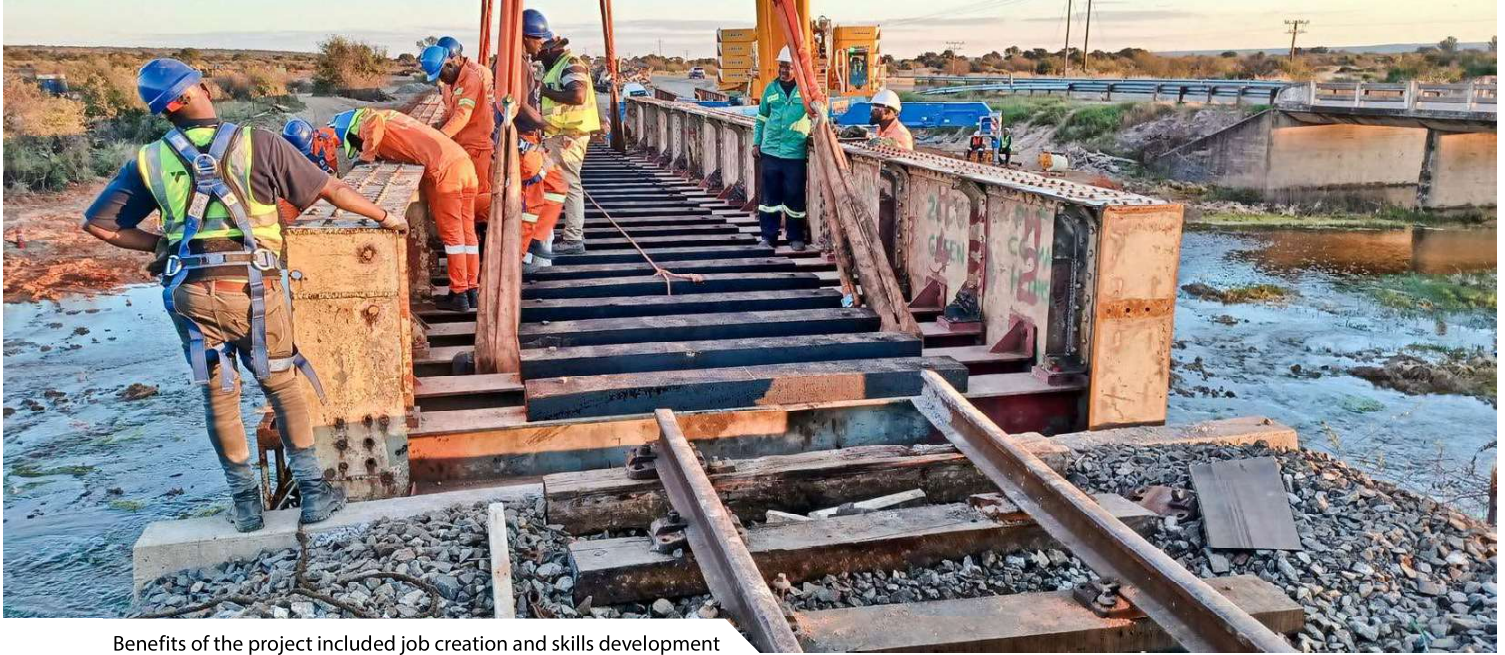
Benefits of the project included job creation and skills development
